Manhole Inspection Summary

Manhole # S41A2_034MH

Insp Date: **4/7/09 12:00 AM**

Location Address: **3724 7th-Brooklyn**

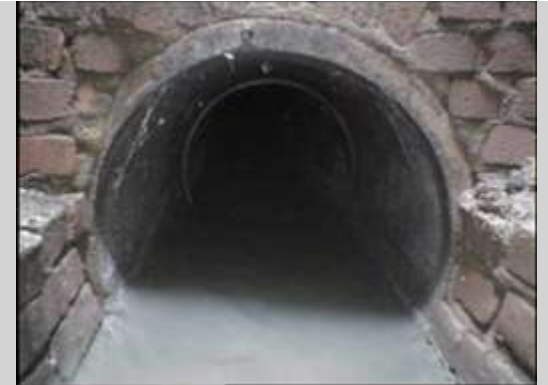
12 O'Clock Outflow

21 in. Circular Gravity Sewer
Pipe Out @ 12 O'Clock

Pipe Height: **21.6** (in.) Rod and Bar (Angled)
Pipe Material: **Clay** ☐ Pipe Lined
Invert Depth: **9.10** (ft.) Flow Characteristics: **Turbulent**
Deposits: ☒ None ☐ Mud ☐ Sludge ☐ Debris ☐ Grease
Silt Depth: (in.) Deposits Extent:
Infiltration: **None** Pipe Seal Cond: **Sound**

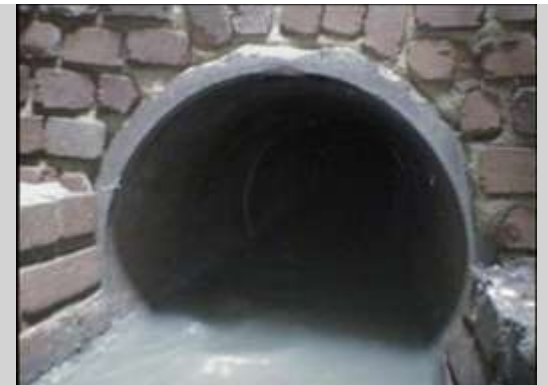
5 O'Clock Inflow

21 in. Circular Gravity Sewer
Pipe In @ 5 O'Clock

Pipe Height: **21.6** (in.) Rod and Bar (Angled)
Pipe Material: **Clay** ☐ Pipe Lined
Invert Depth: **9.05** (ft.) Flow Characteristics: **Turbulent**
Deposits: ☒ None ☐ Mud ☐ Sludge ☐ Debris ☐ Grease
Silt Depth: (in.) Deposits Extent:
Infiltration: **None** Pipe Seal Cond: **Sound**

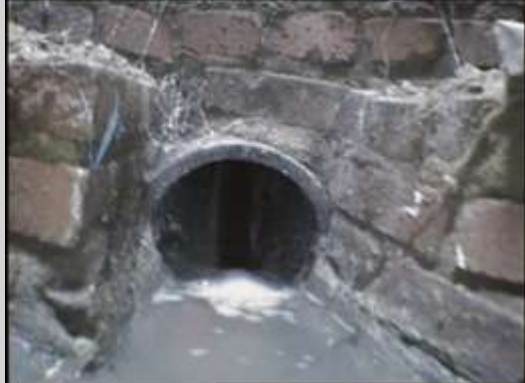
8 O'Clock Inflow

8 in. Circular Gravity Sewer

Pipe In @ 8 O'Clock

Pipe Height: **10.8** (in.) Rod and Bar (Angled)

Infiltration: **None** Pipe Seal Cond: **Sound**
